Manhole Inspection Summary

Manhole # S21KK_037MH

Insp Date: **5/31/07 11:38 AM**

Location Address: **2014 FULTON AVE**

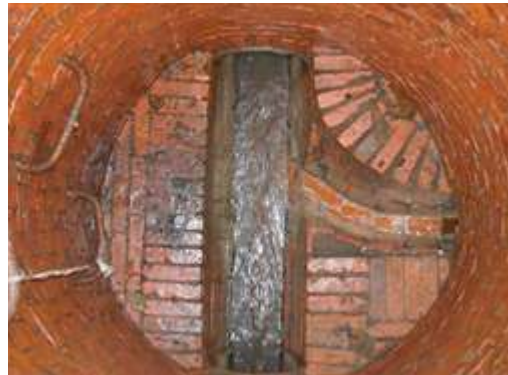
Top View

Comments **RETOOK TOP VIEW PHOTO AS REQUESTED 3-4-09**

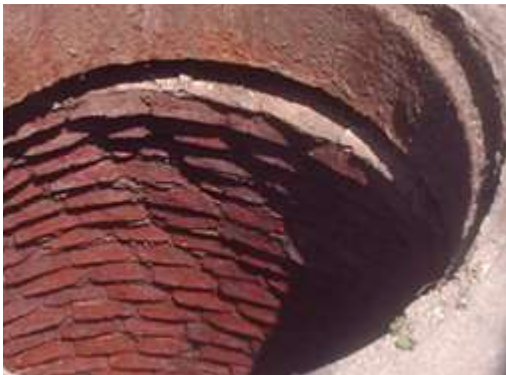
Defect 3

Condition: ☐ Sound ☐ Cracked ☐ Root Intrusion ☐ Loose Brick ☒ **Deteriorated**

CHIMNEY DETERIORATION

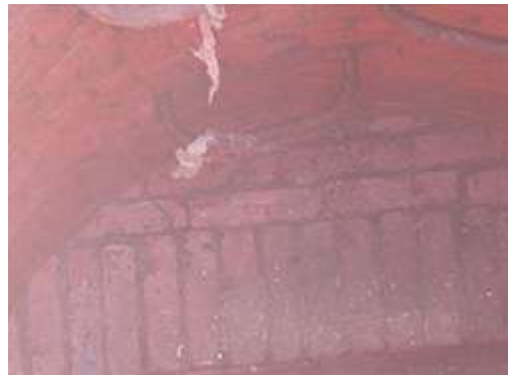
Defect 2

☒ **Evidence Of Surcharge** Depth: **4** (ft.) ☐ Active Surcharge Present

SURCHARGE EVIDENCE ON STEPS

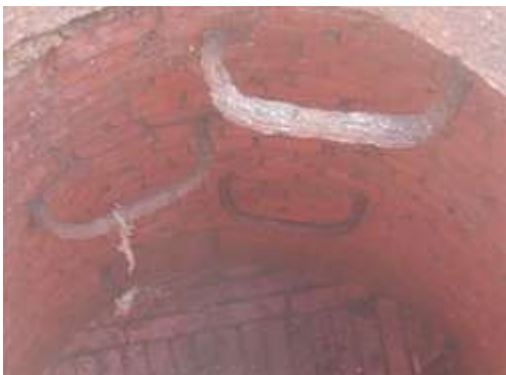
Defect 1

Count: **4** Missing: **0** ☒ **Corroded**

CORRODED STEPS

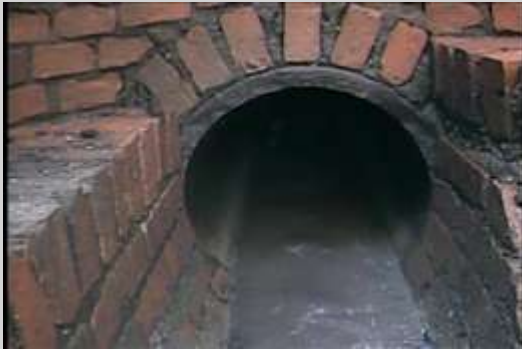
12 O'Clock Outflow

15 in. Circular Gravity Sewer
Pipe Out @ 12 O'Clock

Pipe Height: **12** (in.) Rod and Bar (Angled)
Pipe Material: **Clay** ☐ Pipe Lined
Invert Depth: **8.31** (ft.) Flow Characteristics: **Slow**
Deposits: ☒ None ☐ Mud ☐ Sludge ☐ Debris ☐ Grease
Silt Depth: (in.) Deposits Extent:
Infiltration: **None** Pipe Seal Cond: **Sound**

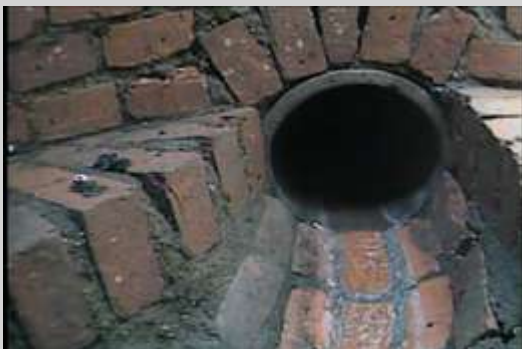
3 O'Clock Inflow

8 in. Circular Gravity Sewer
Pipe In @ 3 O'Clock

Pipe Height: **8.4** (in.) Rod and Bar (Angled)
Pipe Material: **Clay** ☐ Pipe Lined
Invert Depth: **7.35** (ft.) Flow Characteristics: **Slow**
Deposits: ☒ None ☐ Mud ☐ Sludge ☐ Debris ☐ Grease
Silt Depth: (in.) Deposits Extent:
Infiltration: **None** Pipe Seal Cond: **Sound**

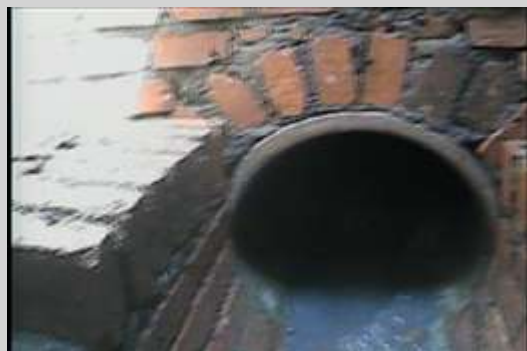
6 O'Clock Inflow

15 in. Circular Gravity Sewer
Pipe In @ 6 O'Clock

Pipe Height: **14.4** (in.) Rod and Bar (Angled)

Pipe Material: **Clay** ☐ Pipe Lined

Invert Depth: **8.05** (ft.) Flow Characteristics: **Slow**

Deposits: ☒ None ☐ Mud ☐ Sludge ☐ Debris ☐ Grease

Infiltration: **None** Pipe Seal Cond: **Sound**
